***Report No. UT-04.04***

***A STUDY OF THE I-15  
RECONSTRUCTION PROJECT  
TO INVESTIGATE VARIABLES  
AFFECTING BRIDGE DECK  
CRACKING***

**Utah Department of Transportation  
Research Division**

**July 2004**

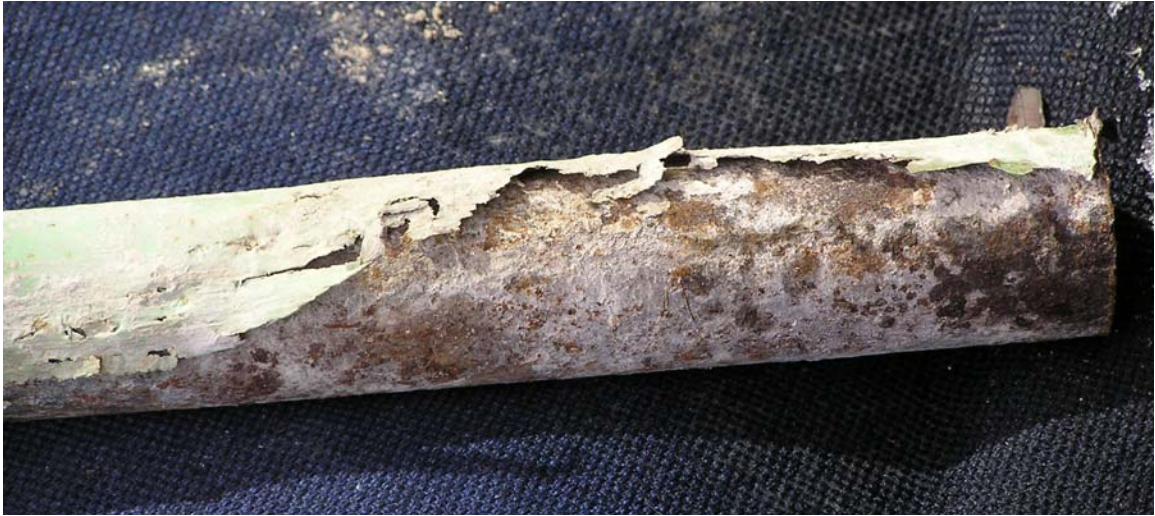
at a 13-mm (0.5 in) depth.” Additionally the epoxy coated reinforcement was visually inspected for damage, coating thickness, and adhesion. In all but one bridge deck older than four years, the epoxy coatings were debonding from the reinforcing bars. It generally takes longer than four years for chlorides to reach a sufficient level of concentration within the deck to initiate corrosion of reinforcing steel (Pyć et al., 2000). Figure 1 is a photograph of a typical joint reinforcing dowel that was removed from a concrete pavement slab after only a few years of service in Salt Lake City. The debonding of the epoxy coating can readily be seen along the entire length of this specimen.

**Figure 1 - Photograph of a typical joint reinforcing dowel removed from a concrete pavement slab after only a few years of service.**

Pyć et al. (2000) suggests that epoxy coated reinforcement does not provide any additional service life for concrete bridge decks and recommends that the Virginia Department of Transportation discontinue the use of epoxy coated reinforcement in bridges. There is considerable disagreement in the current literature about the effectiveness of epoxy coated reinforcement. In “ideal” laboratory settings, epoxy coating tends to prevent the oxidation of reinforcing steel. However, for practical real-world use the coating does not appear to be effective.

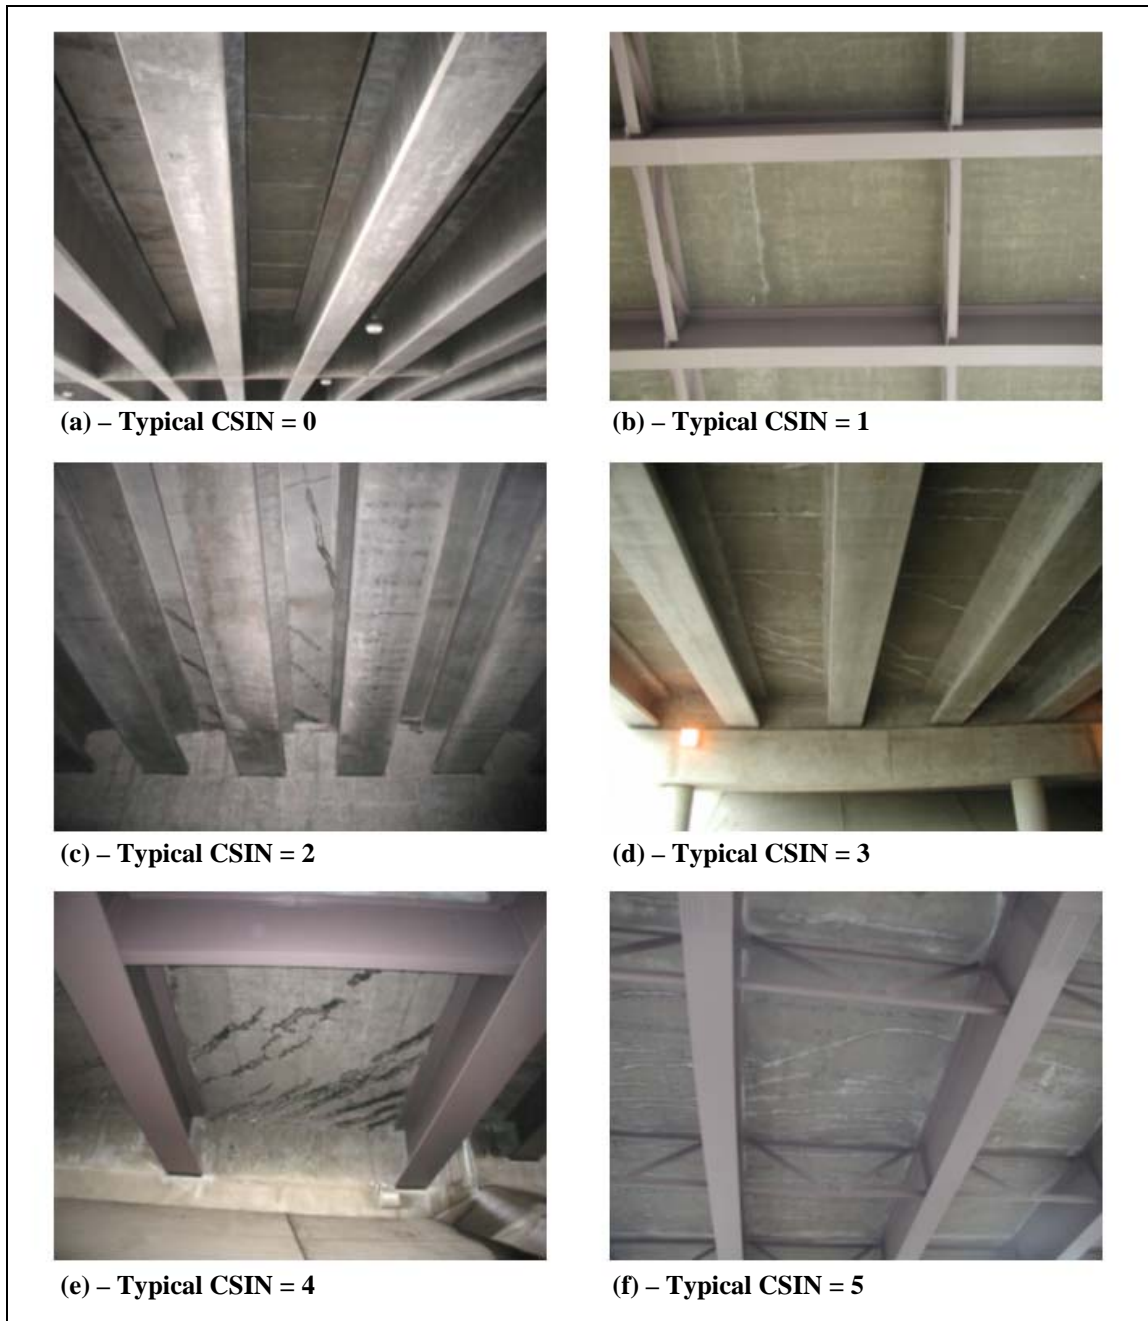
**Figure 2 - Photos of the undersides of new I-15 bridge decks depicting typical amounts of cracking associated with each CSIN value. The “lines” observed on the deck in (a) are precast panel joints and not cracks.**

It is important to note that only one bridge in the study (Bridge No. 3.5) was classified with a CSIN of 0. Every other bridge had more than one visible crack on the deck underside. No bridges were ranked with a CSIN of 4. Heavy cracking on any bridge deck was not limited to the bridge span ends.

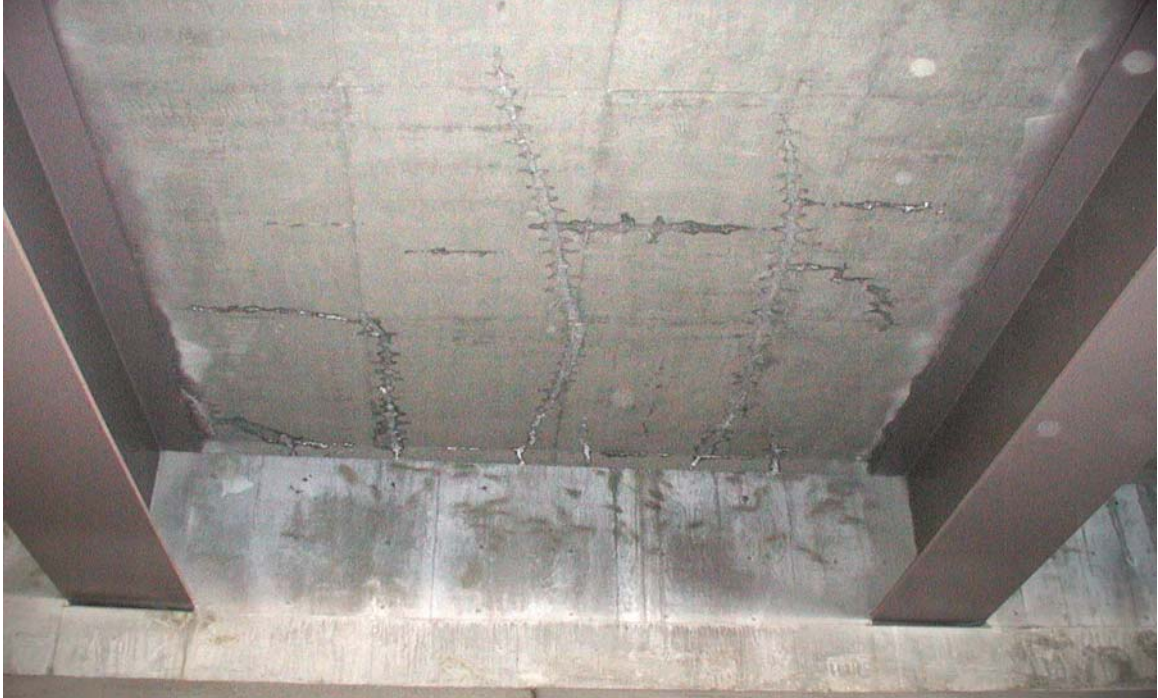
Bridge No. 50 is a short, single-span, SC bridge with integral abutments. This bridge has many transverse and diagonal cracks along with the longitudinal cracks shown in Figure 9. Figure 10 illustrates that for bridges with longitudinal cracking, cracking severity increases as bridge decks get wider.

**Figure 9 - Photo taken January 8, 2003 of the underside of Bridge No. 50. The longitudinal cracks are radiating from the north integral abutment.**

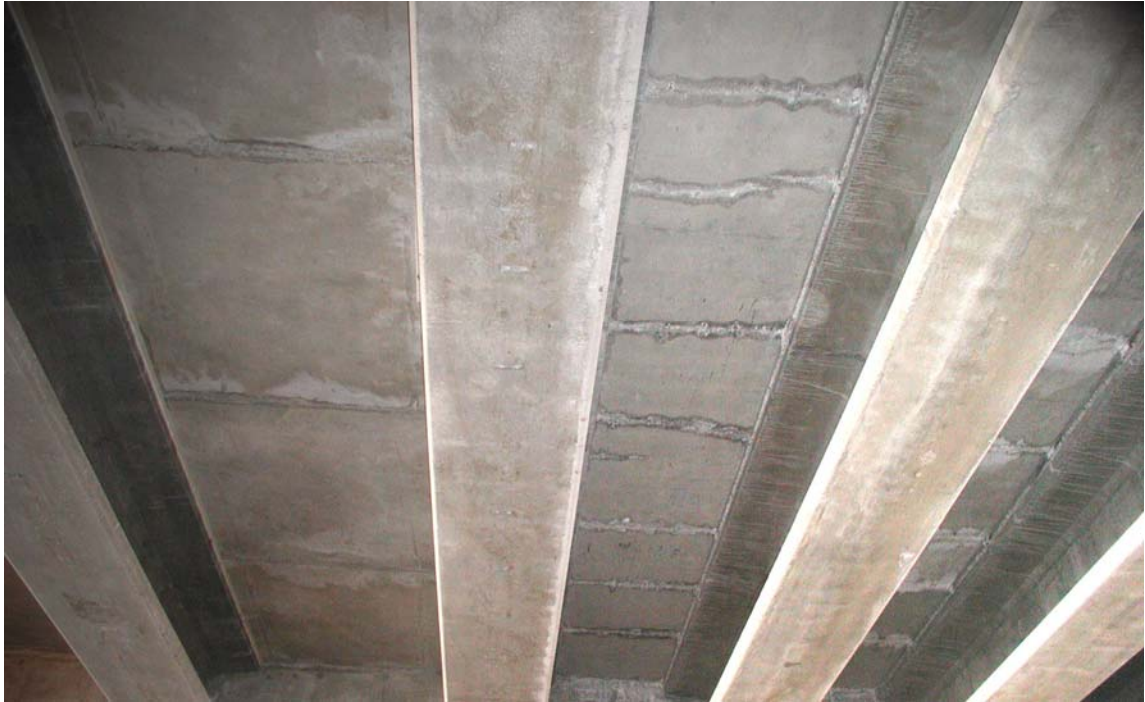
constructed, additional lanes were added to the west side of the bridge. This widened portion of the bridge was built without deck panels. From the underside of the bridge, an interesting contrast can be seen between the precast panel portion of the deck and the cast-in-place portion. As seen in Figure 11, the west deck section has regularly spaced transverse cracks that are spaced approximately twice as close as the east side panel joints. During rain storms, water has been observed on the underside of both sections of the deck on multiple occasions. On the east section of the bridge, the water was observed at the precast deck panel joints. On the west section the water was observed at many of the transverse cracks

**Figure 11 - Photo of the underside of Bridge No. 224 taken Jan. 4, 2003. The east portion of the deck (left side of photo) was constructed with precast panels and the west portion was cast-in-place.**
